Equipment Failure - Transformer

Equipment Failure - Primary Conductor

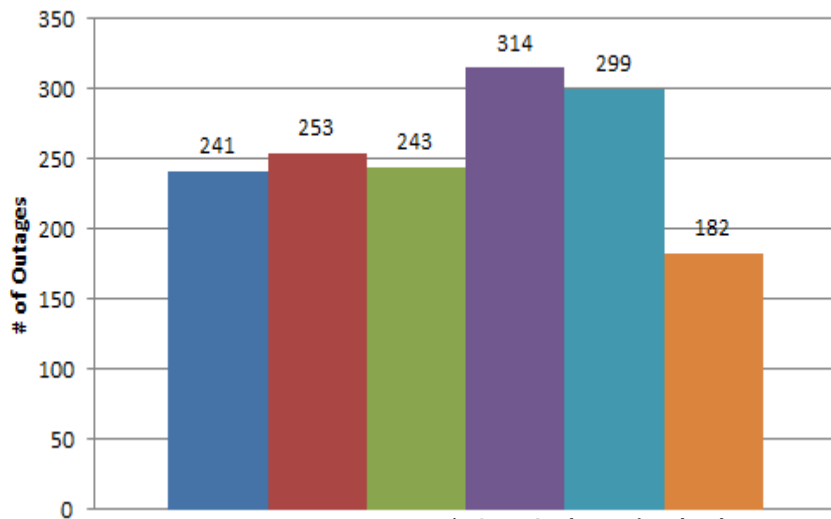
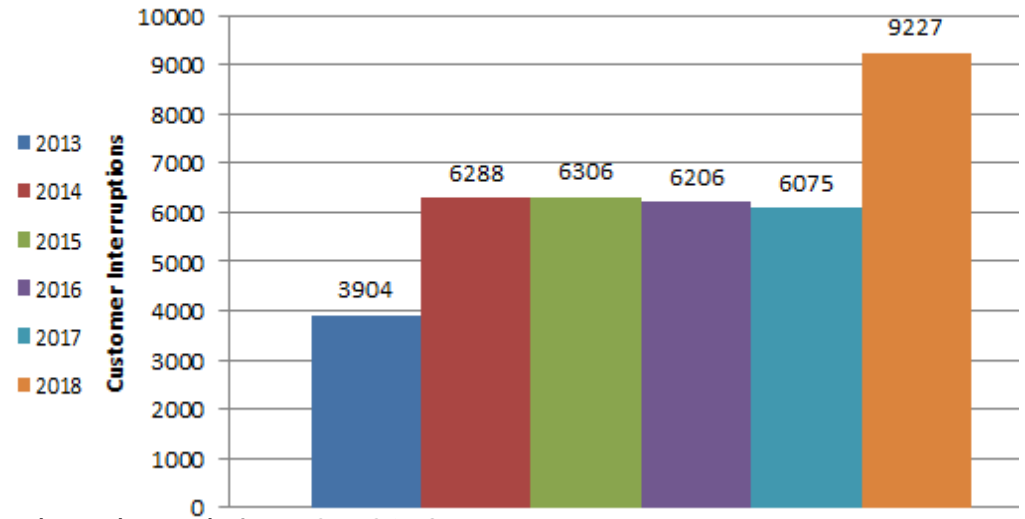
Transformer failures are typically the result of being exposed to conditions outside the design specifications for the transformer or external influences. These include but are not limited to excess voltage due to lightning, excess current through unusual load spikes, and external flashovers due to lightning, animals, and mechanical damage.

- Over Voltage (I.E. Lightning)
- Over Current (I.E. Winter Cold Snap, Summer Heat Wave, Unusual Peak Loading)
- External Flashovers (I.E. Animals, Lightning, Mechanical Damage)

★ Transformer Failures had a significant increase in January 2018 due to extreme freezing temperature days. Customer's Electric Water Heaters/Heaters consume higher loads than historically expected. When these overload failures occur the replacement transformer is upgraded in size capacity to prevent future failures.

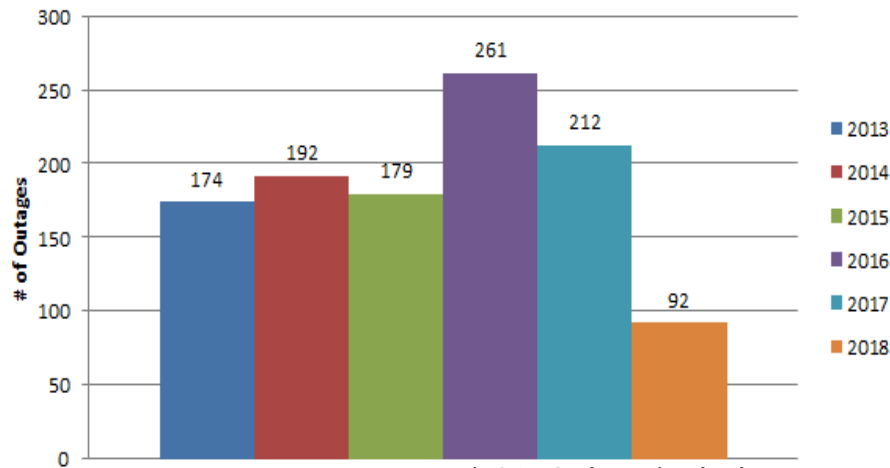
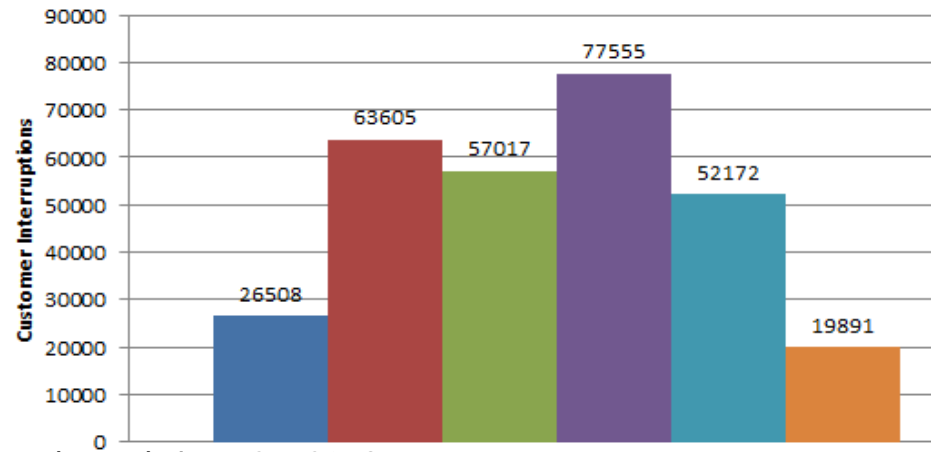
Primary Conductor becomes structurally weakened over time when exposed to the elements and constant current. Overloaded conductor may sag to the point of structural failure. Mechanical damage from prior events (I.E. Storm, Vegetation, vehicles, etc) may lead to structural failure from the structural deficiencies that were introduced that did not result in a failure at that time.

- Exposure to the elements and constant current over time reduces structural integrity which may lead to structural failure
- Overloaded Conductor in terms of ampacity may lead to structural failure
- Mechanical damage from prior events may lead to structural failure (I.E. Storm, Vegetation, Vehicles, etc)

- Defects in conductor insulation
- Overloaded Conductor in terms of ampacity may lead to insulation failure
- Insulation nicks due to dig-ins that lead to failure over time

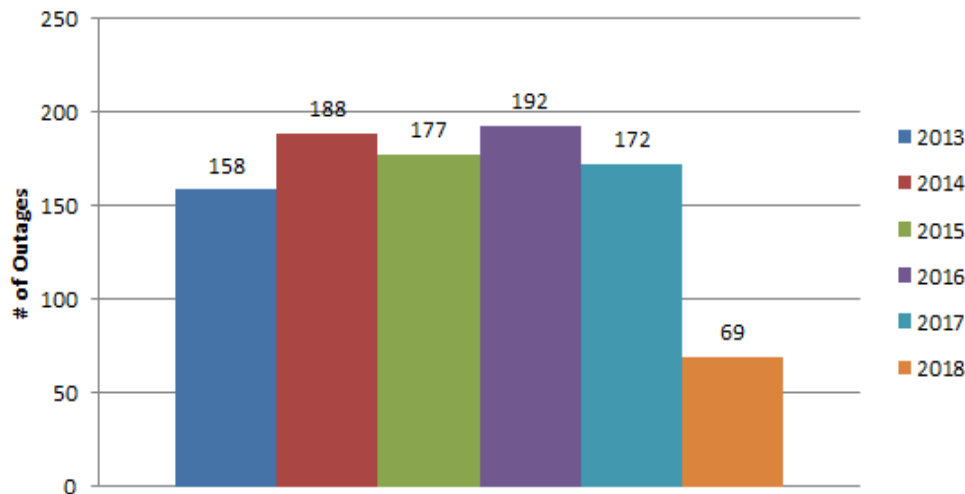
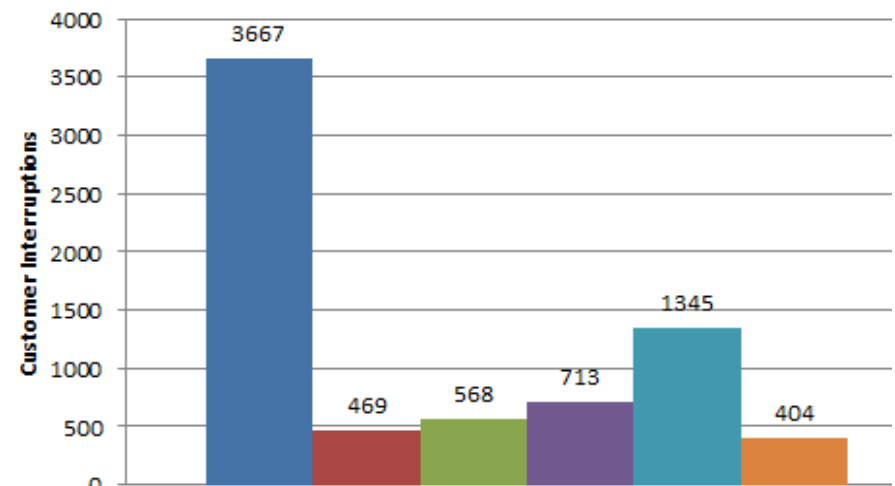
Secondary/Service Conductor

Failure of the conductor/ wire that is usually at 120/240v that runs between poles or from the pole to the house.

- Connector corrosion on either the source connection or load connection may lead to electrical and/or structural failure
- Insulation breakdown due to mechanical damage while in service which may lead to electrical failure (I.E. trees/limbs, wind borne debris, public inflicted damages)
- Squirrels chewing the conductor or neutral may lead to structural or electrical failure

- Connector corrosion on either the source connection or load connection may lead to electrical and/or structural failure
- Insulation breakdown due to defects present in the conductor which may lead to electrical failure
- Insulation nicks due to dig-ins that lead to failure over time

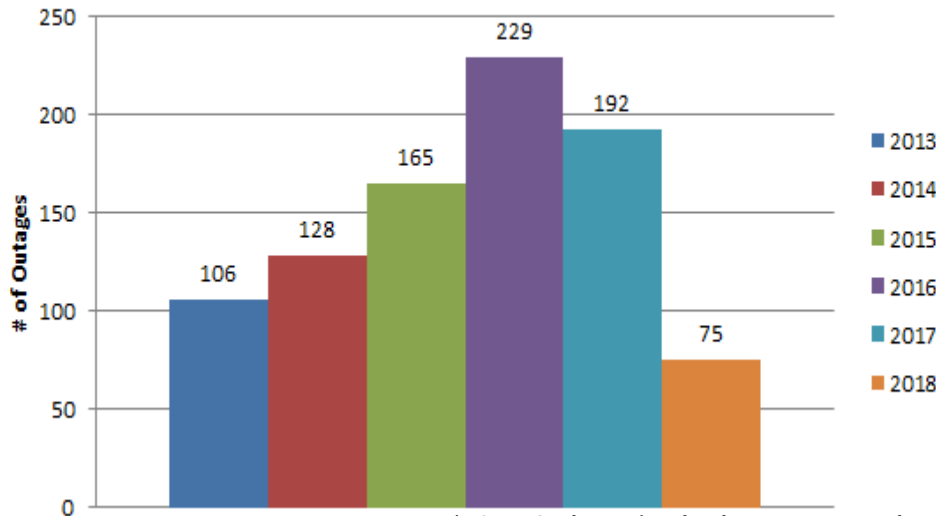
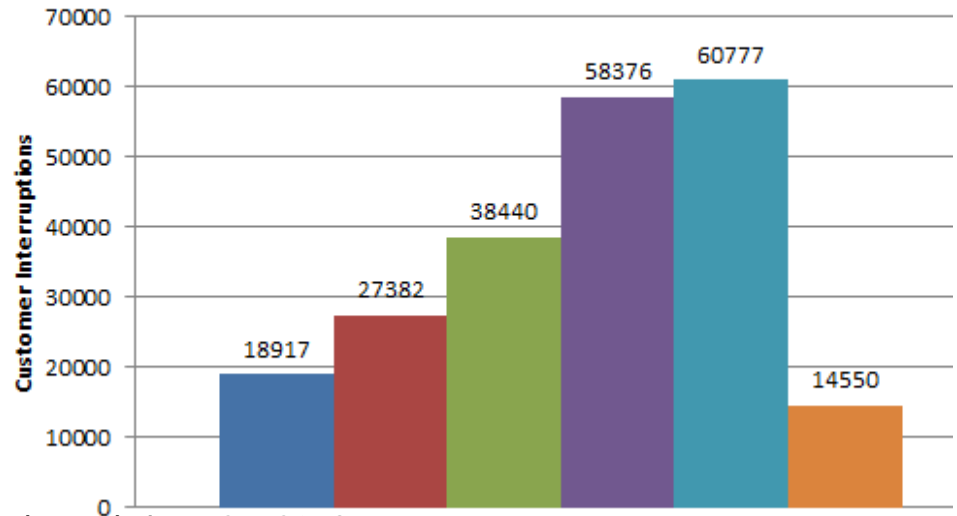
Equipment Failure - Crossarm

Crossarms are typically Douglas Fir treated with Pentachlorophenol (Penta) as a wood preservative. New Orleans is in the highest wood deterioration zone (zone 5) as defined by the NESC. Over time the wood preservative becomes less effective against fungal and insect decay which will eventually lead to structural failure.

- *Inherently high levels of fungal decay due to geography and climate resulting in rapid wood decay*

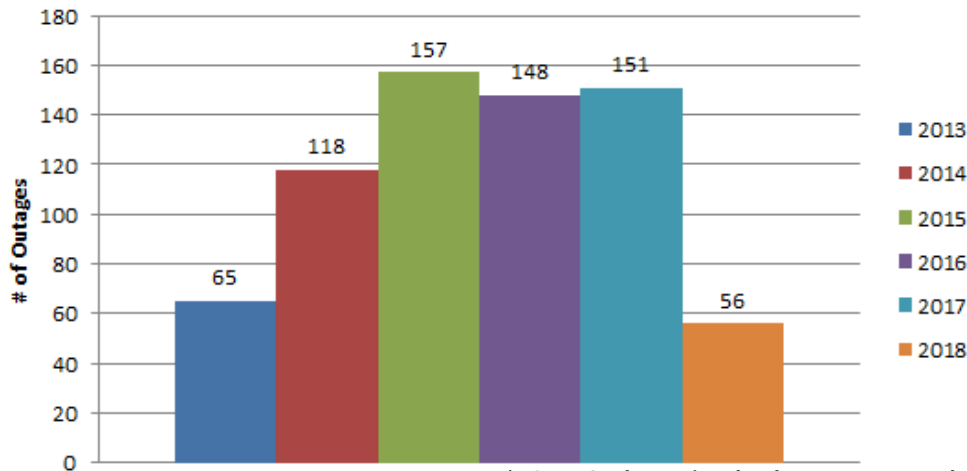
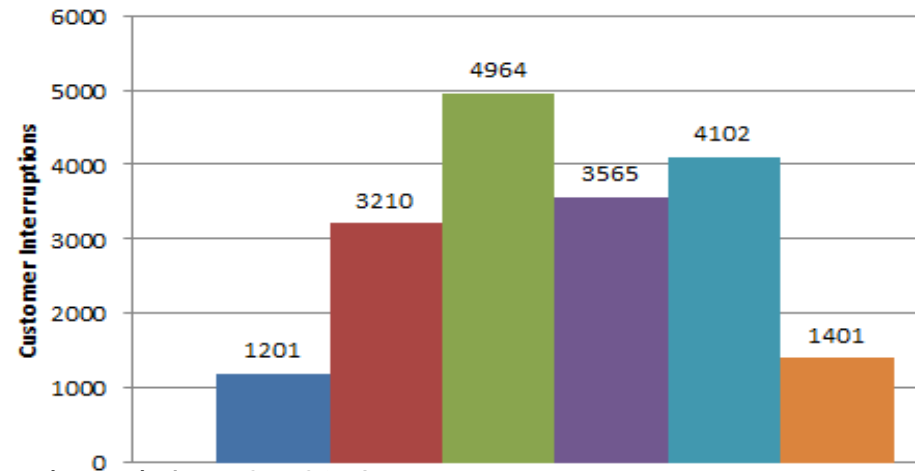
Equipment Failure - Fuse Link

A fuse link is a replaceable element that is a portion of the Fuse Switch. The fuse link extinguishes due to higher than normal current transfers. This overcurrent protection device isolate faulted feeder branches and/or equipment on the distribution system.

- Normal fuse operation as a result of other causes (I.E. Lightning, Vegetation, Wind Borne Debris, Animals, etc) miscoded as a fuse link failure. Fuse links are meant to blow open when a fault occurs downstream.*
- Miss-coordination between other protective devices due to replacement with an improperly sized fuse on a major storm may result in an undesired fuse link operation.*
- Fuse Barrels may deteriorate over time through normal weathering and contamination resulting in an inability to open during a fault.*

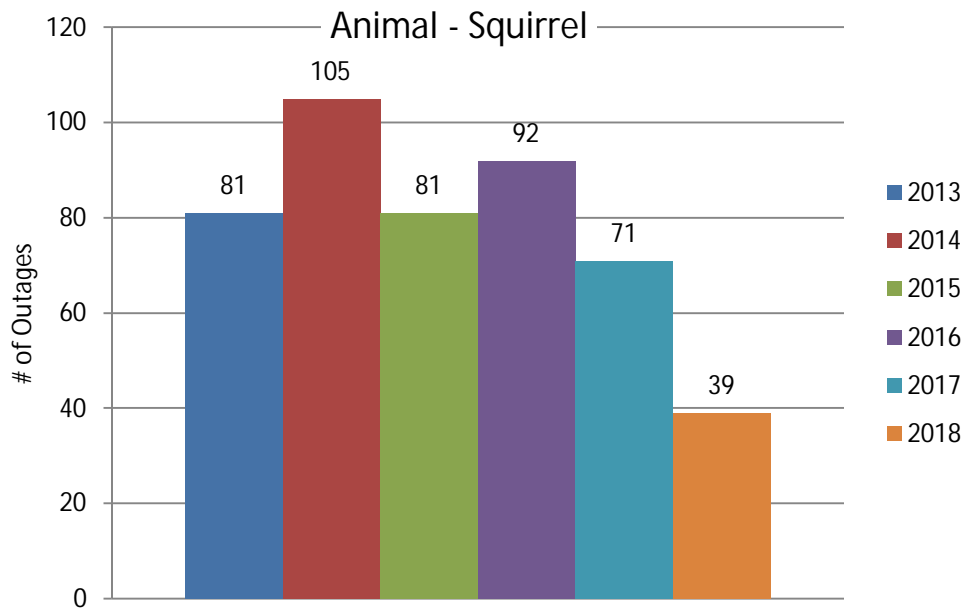
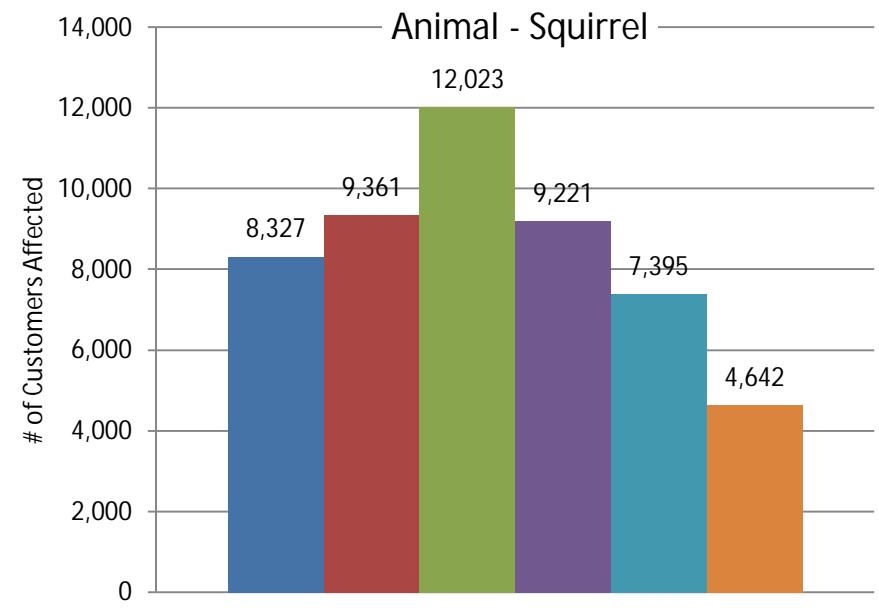
Squirrels use Entergy’s poles, wires, and transformers the same as they do tress and limbs. Entergy’s wire is sometimes a safe way to cross a street and the top of the transformer may be viewed as a safe place to store food. Any space between two different voltage potentials large enough for a squirrel to make a connection may result in an outage.

- Inadequate spacing/insulation between conductors or grounded hardware may result in a squirrel making contact between two voltage potentials.*
- Increased population of squirrels in an urban environment.*

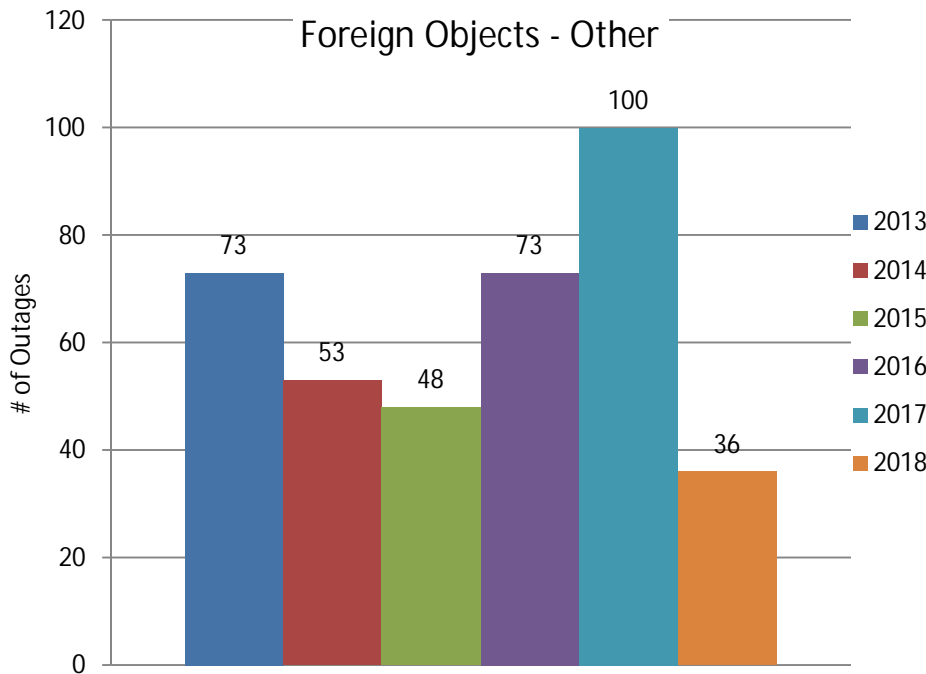
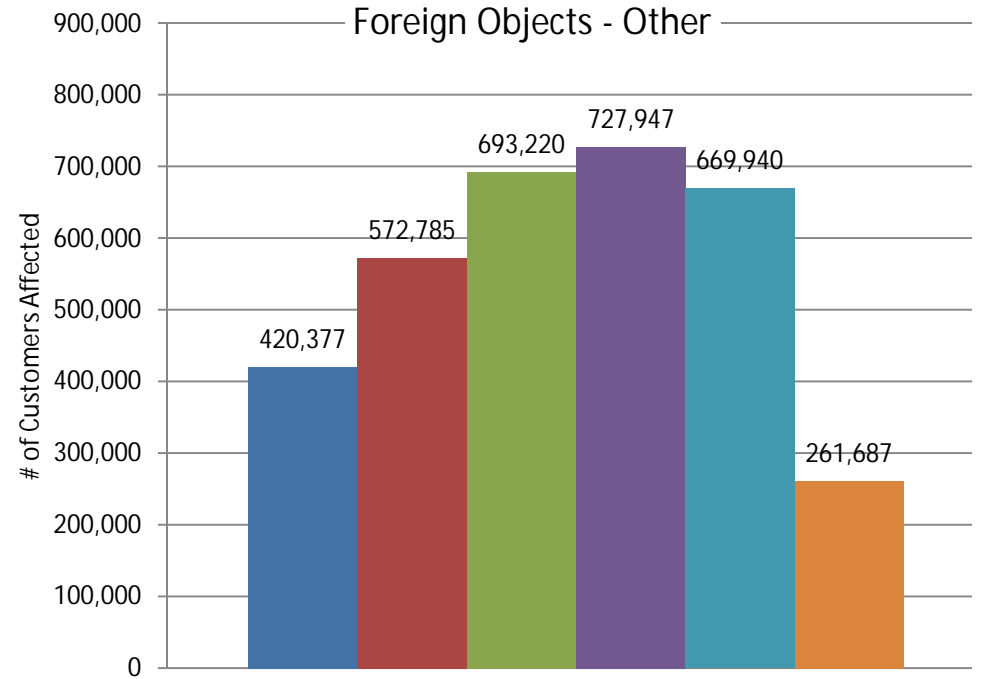
Foreign objects such as Mylar balloons, signs, metal rooftops, and other wind borne debris may become entangled in overhead facilities and result in an outage. These types of outages are non-controllable.

- Non-Controllable Public Inflicted Damages
- Non-Controllable Wind Bourne Debris

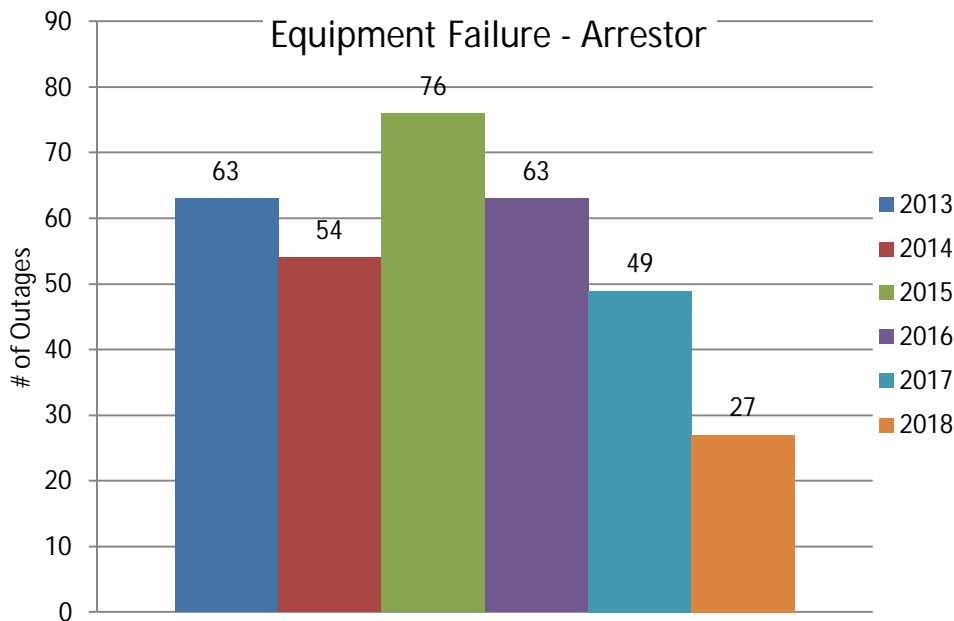
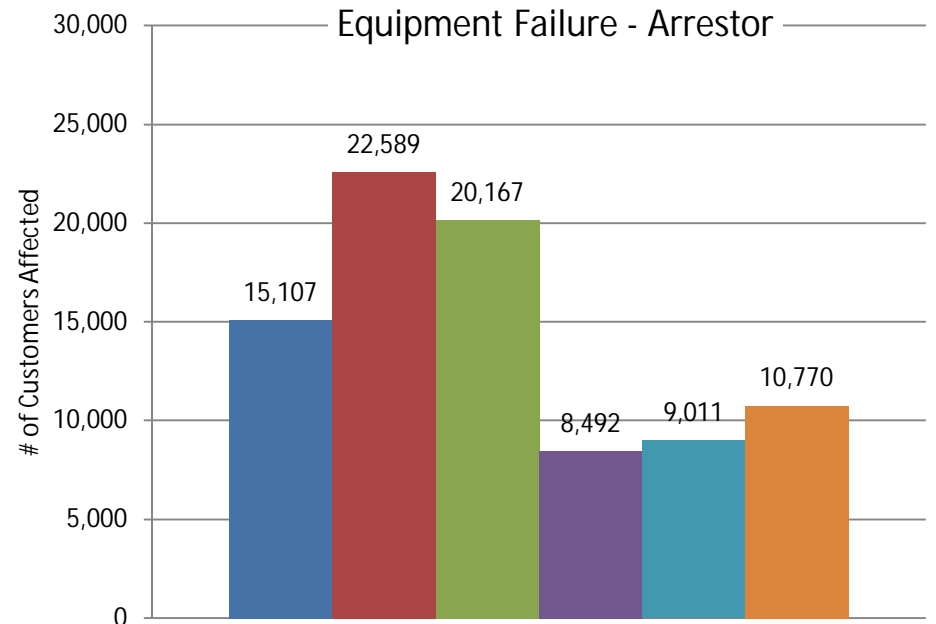
Lightning Arrestors have an inherent failure rate chance that the arrestor will open during the course of interrupting a lightning event which is how arrestors are designed to operate when they fail. Damage may occur to hardware in the immediate proximity during the event. Arrestors can also cause a permanent fault if exposed to conditions outside their design parameters. These conditions are but not limited to greater lightning voltage than designed, greater lightning current than designed or improper ground resistance due to copper ground wire theft or other grounding conditions.

- There is a chance that an arrestor may open and become inoperable after each event
- There is a possibility that damage to surrounding hardware in close proximity may occur during a normal arrestor failure
- Conditions outside design parameters may result in a permanent fault occurring

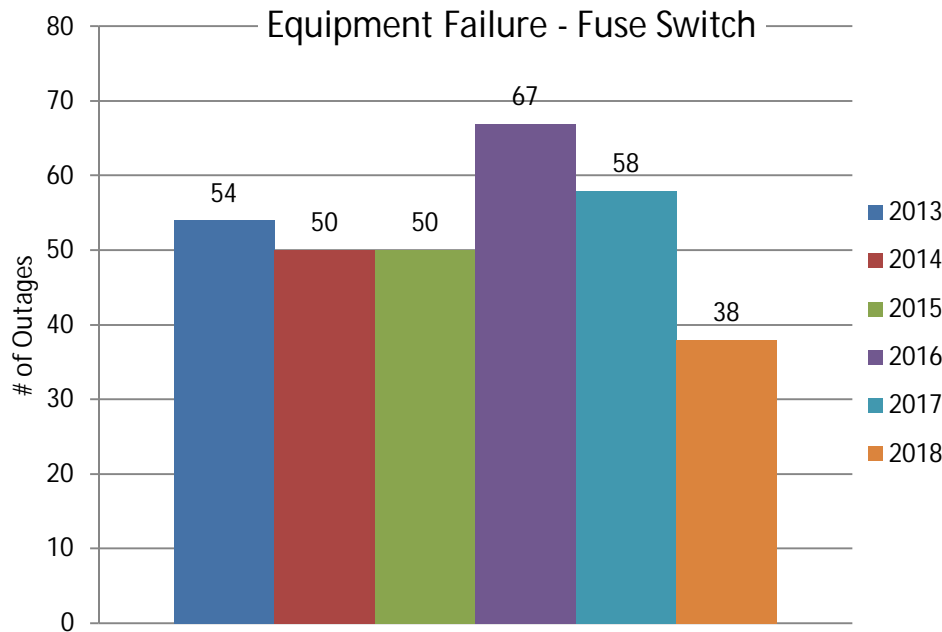
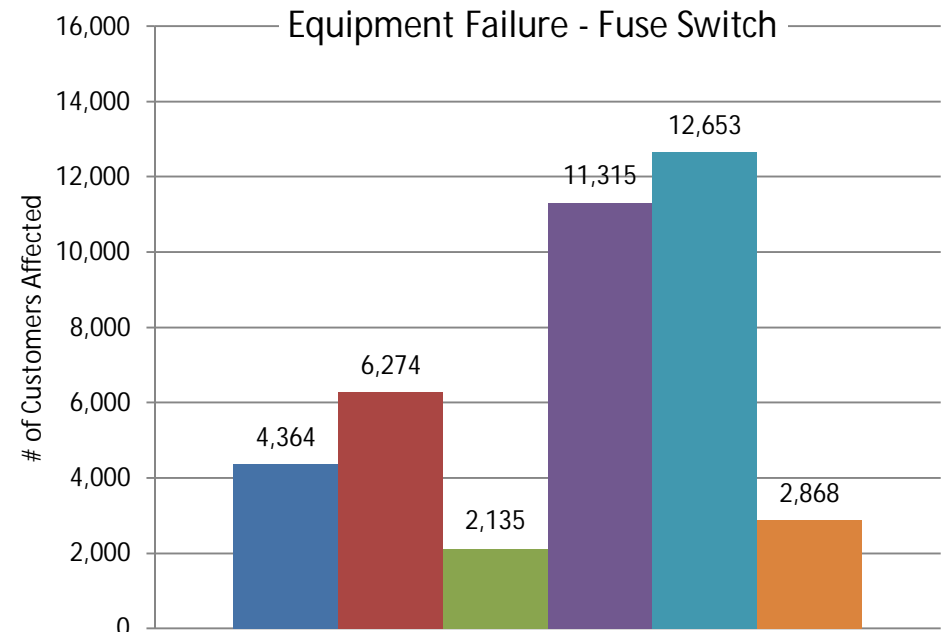
The fuse itself inside a fuse cutout switch. Blown due to a downstream fault or overload.

- *Normal fuse operation as a result of other causes (I.E. Lightning, Vegetation, Wind Borne Debris, Animals, etc) miscoded as a fuse link failure. Fuse links are meant to blow open when a fault occurs downstream.*
- *Miss-coordination between other protective devices due to human error in sizing or replacement with an improperly sized fuse on a major storm may result in an undesired fuse link operation.*
- *Fuse Barrels may deteriorate over time through normal weathering and contamination resulting in an inability to open during a fault.*

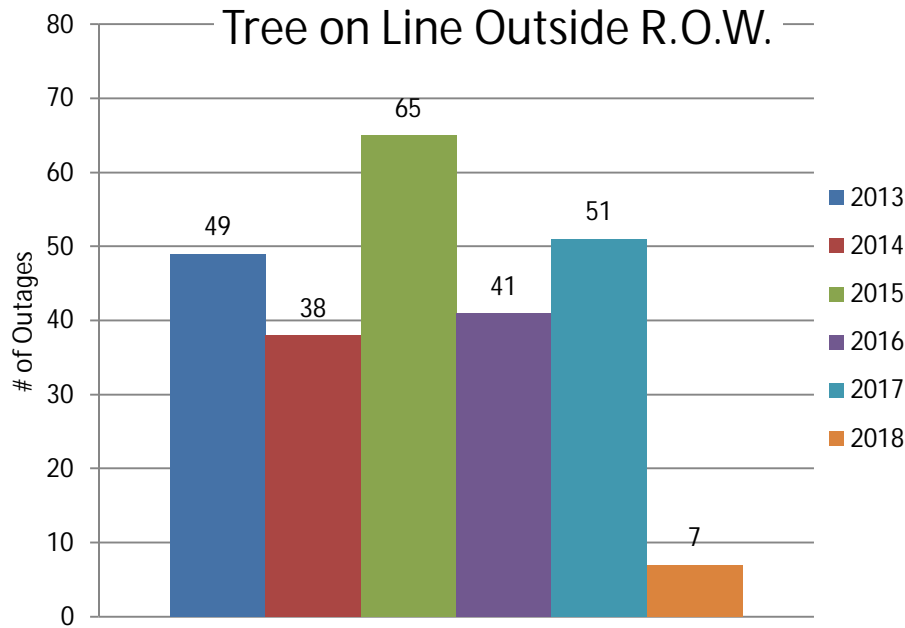
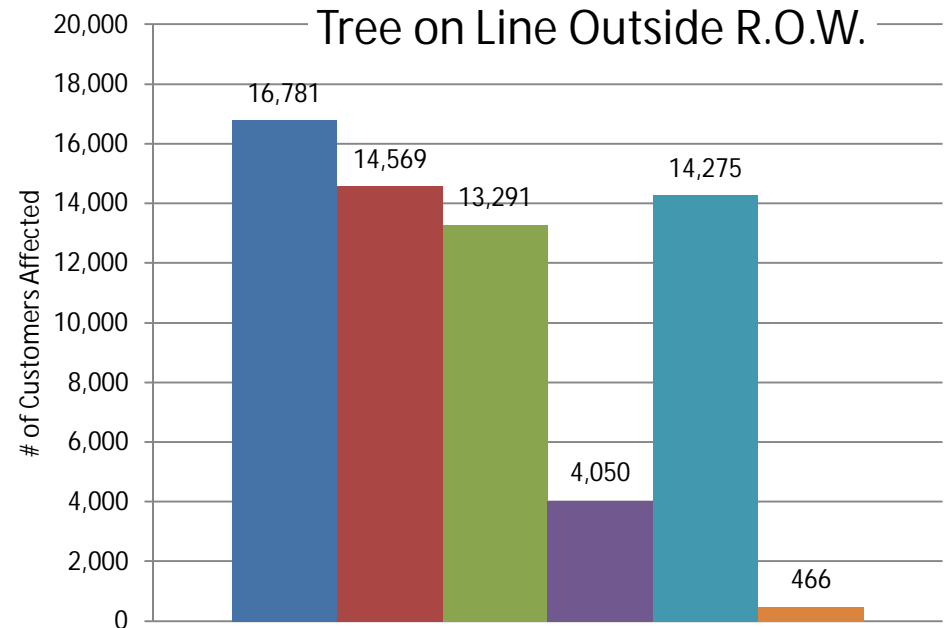
Trees growing outside of the R.O.W. are non-controllable outage events.

- Trees growing outside the R.O.W. are non-controllable events.

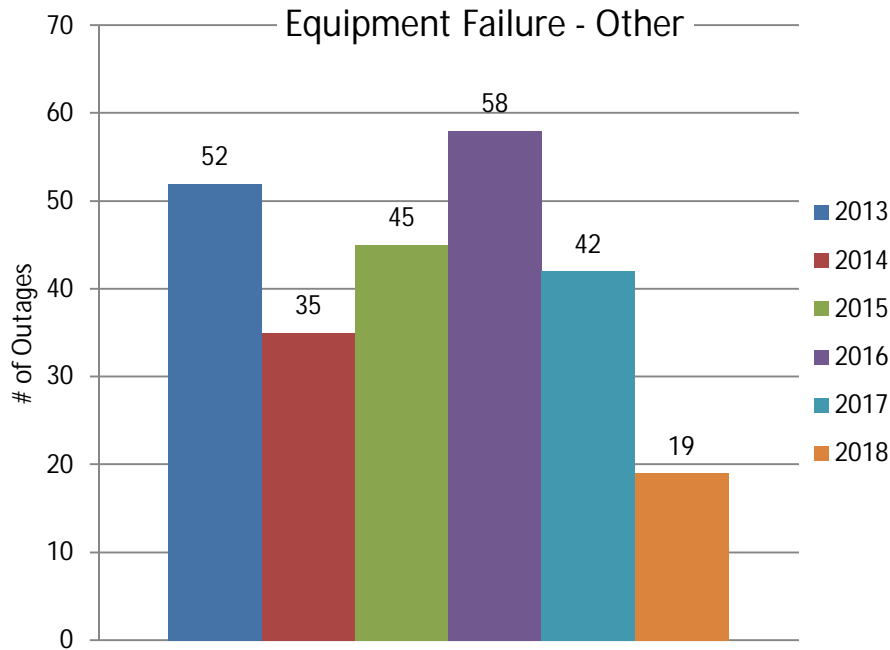
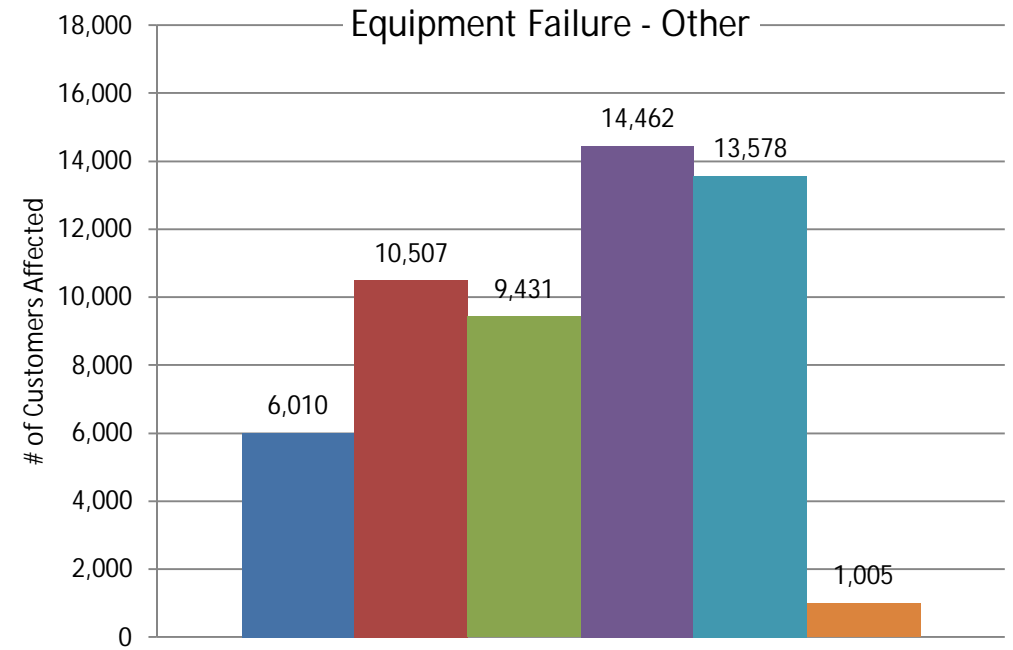
This field describes any outage caused by hardware that is otherwise not listed as an individual cause code. Typically this cause code is reserved for minor or unique hardware.

- *Connector Corrosion may lead to electrical failure*
- *Lightning damage from either prior or current events may lead to electrical failure*

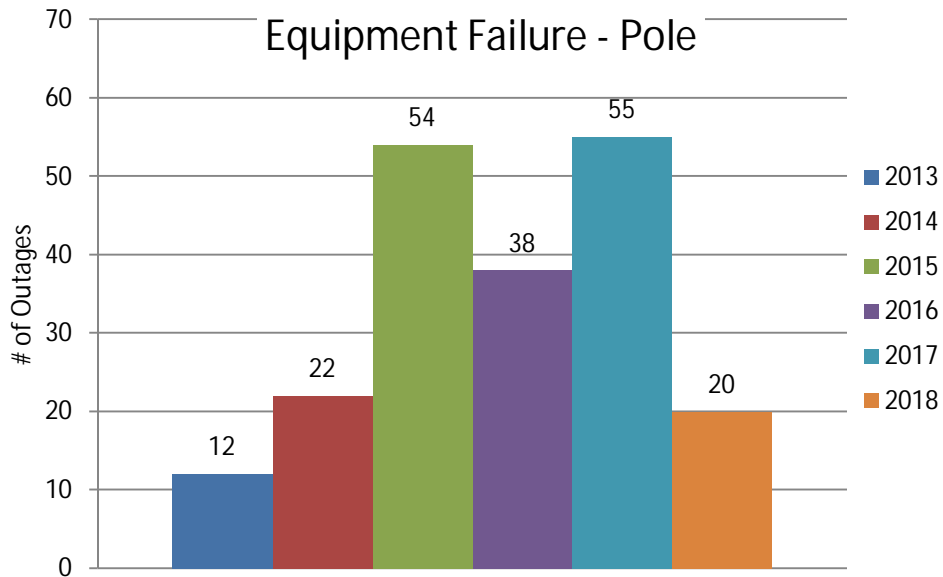
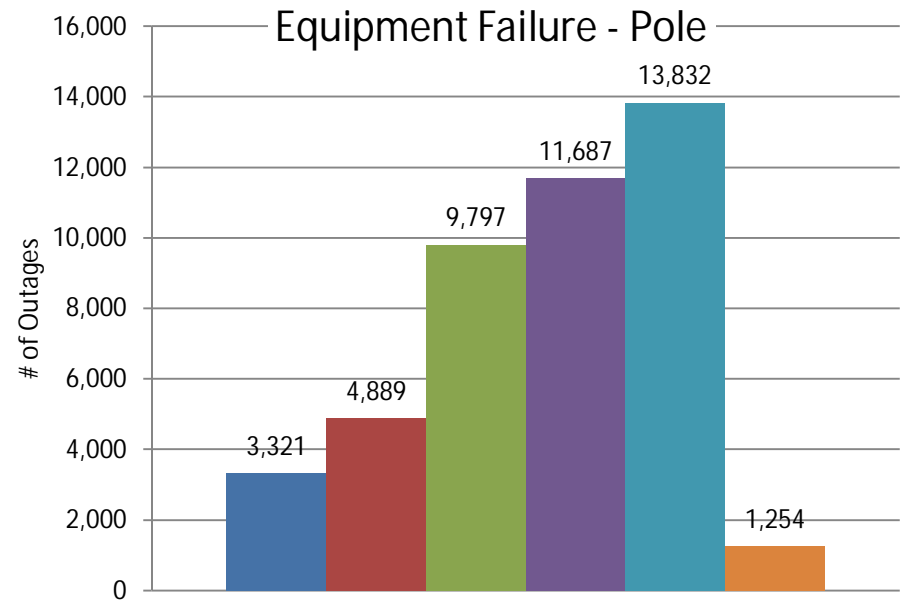
The majority of poles in New Orleans are southern pine with creosote as the wood preservative. New Orleans is in the highest wood deterioration zone(zone 5) as defined by the NESC. Over time the wood preservative becomes less effective against fungal and insect decay which will eventually lead to structural failure. All new poles are treated with Chromated Copper Arsenate (CCA) which is chemically bonded to the wood which greatly increases the wood preservative longevity.

- Inherently high levels of fungal decay due to geography and climate resulting in rapid wood decay
- Structural damage due to other factors (I.E. Vehicles, Trees, Limbs, Public Inflicted Damages, etc) structurally weaken poles over time which may result in structural failure
