Equipment Failure - Transformer

Equipment Failure - Primary Conductor

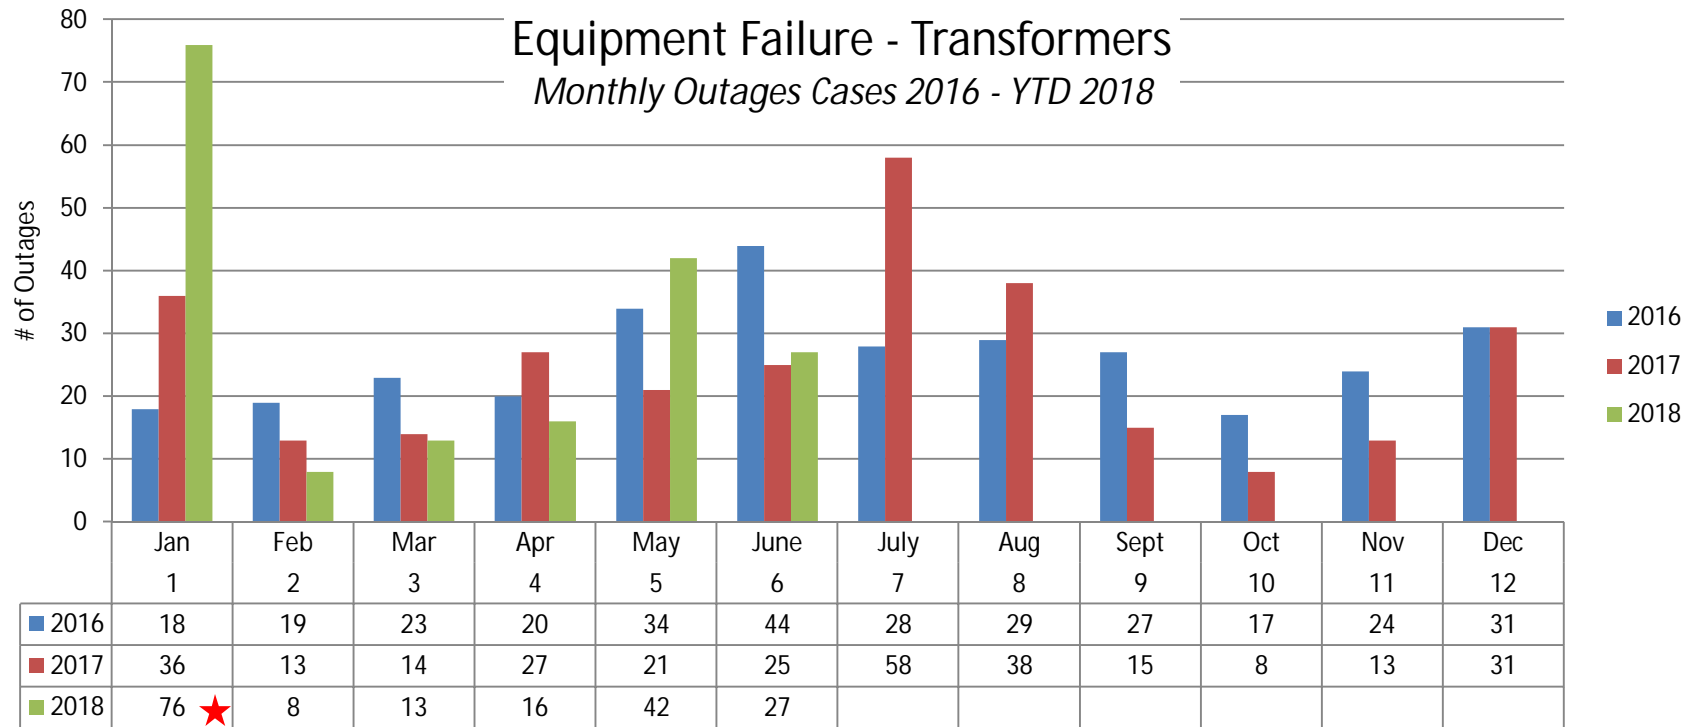
★ Transformer Failures had a significant increase in January 2018 due to extreme freezing temperature days. Customer's Electric Water Heaters/Heaters consume higher loads than historically expected. When these overload failures occur the replacement transformer is upgraded in size capacity to prevent future failures.
